Manhole Inspection Summary

Manhole # S17M__002MH

Location Address: **2502 LEHMAN ST**

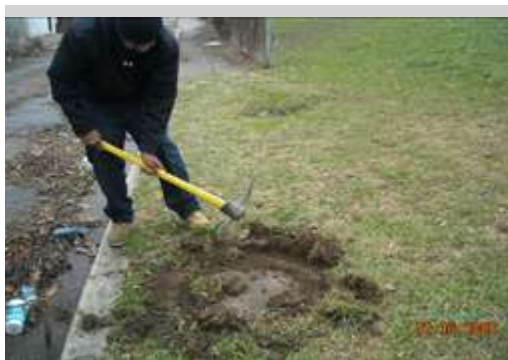
MISC.

EXPOSING MANHOLE

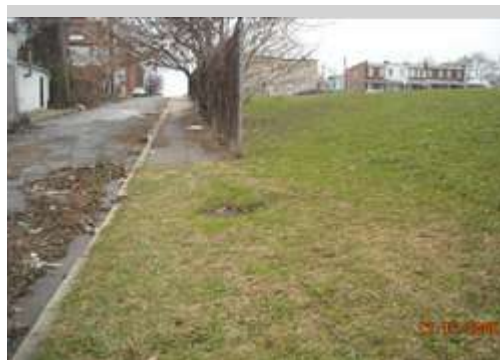
MISC.

AREA PRIOR TO EXPOSING

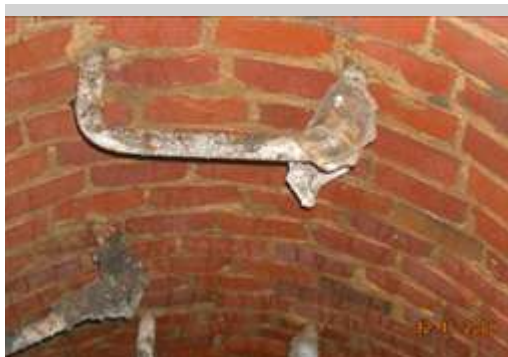
Defect 4

Surcharge ☒ Evidence Of Surcharge Depth: **6** (ft.) ☐ Active Surcharge Present

SURCHARGE EVIDENCE

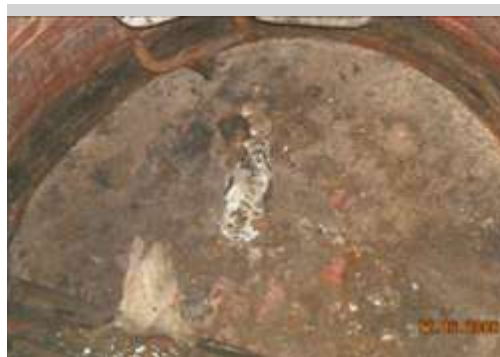
Defect 3

Condition: ☐ Sound ☐ Cracked ☐ Root Intrusion ☐ Deteriorated ☐ Leaks ☒ Debris

DEBRIS ON BENCH

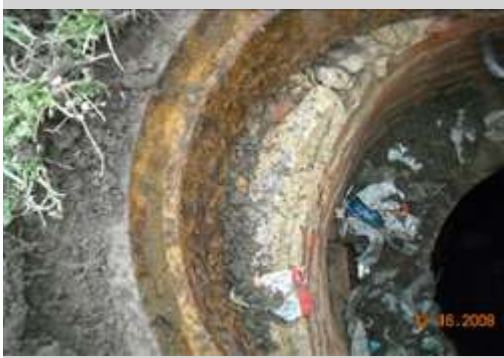
Defect 2

Frame Offset: **3.5** (in.) Condition: ☒ Sound ☐ Cracked ☐ Leaks

FRAME OFFSET

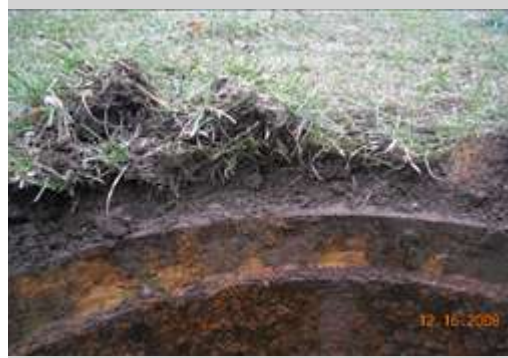
Defect 1

Cover Shape: **Circular** Diameter: **24** (in.) Length: **0** (in.) Dist A/B Grade: **-1** (in.)

FRAME BELOW GRADE

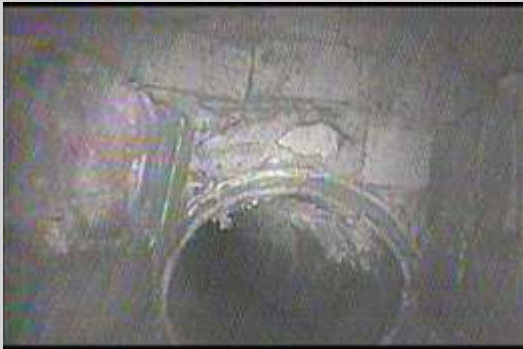
12 O'Clock Outflow

Pipe Height: **8.4** (in.) Rod and Bar (Angled)
Pipe Material: **Clay** ☐ Pipe Lined
Invert Depth: **11.69** (ft.) Flow Characteristics: **Slow**
Deposits: ☐ None ☐ **Mud** ☐ Sludge ☐ Debris ☒ **Grease**
Silt Depth: **1** (in.) Deposits Extent: **Light**
Infiltration: **None** Pipe Seal Cond: **Sound**

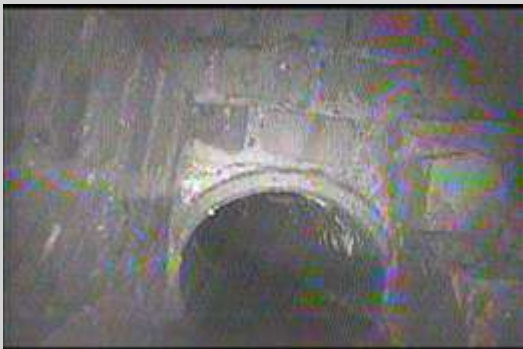
6 O'Clock Inflow

Pipe Height: **8.4** (in.) Rod and Bar (Angled)
Pipe Material: **Clay** ☐ Pipe Lined
Invert Depth: **11.65** (ft.) Flow Characteristics: **Slow**
Deposits: ☒ None ☐ **Mud** ☐ Sludge ☐ Debris ☐ Grease
Silt Depth: **0** (in.) Deposits Extent:
Infiltration: **None** Pipe Seal Cond: **Sound**

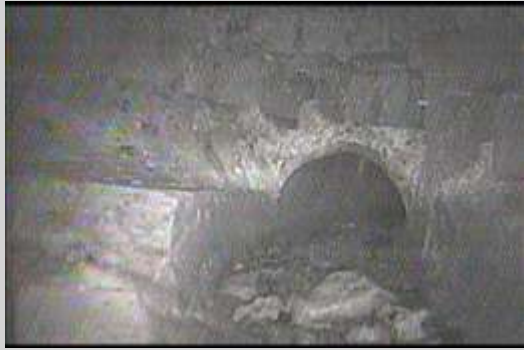
7 O'Clock Inflow

Deposits: ☐ None ☒ **Mud** ☐ Sludge ☐ Debris ☐ Grease

Silt Depth: **2** (in.) Deposits Extent: **Medium**

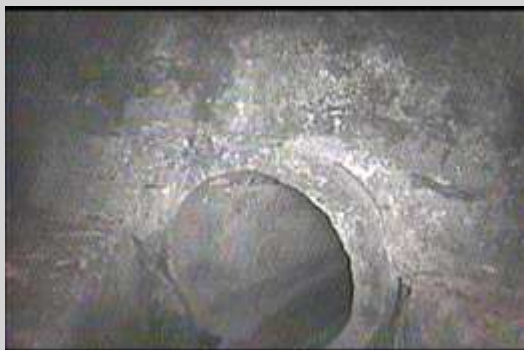
9 O'Clock Inflow

Deposits: ☒ None ☐ Mud ☐ Sludge ☐ Debris ☐ Grease
